# Local Asbestos Management Plan (LAMP) and Asbestos Register

## 01030 - Misson Primary School

**Site address:** Dame Lane Misson Doncaster South Yorkshire DN10 6EB

**Report Date:** 19/06/2025

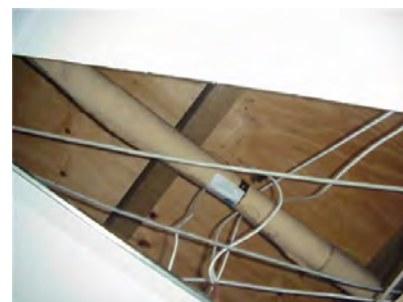
Ref	Status	Sample No.	Location	Extent	Type	Material score	Material risk	Priority	Overall risk	Resurvey date
71	Presumed	01030-01-01-P12	01 00 School Building 001 CirculationGround : CEILING VOID	4 LINEAR METRES	Chrysotile	5	B	7	Low	12/06/2026

Paper lining to the underside of versal insulation to pipework within the ceiling void presumed to contain asbestos as previous sample no. 01030-01-22-08.

- Restrict Access

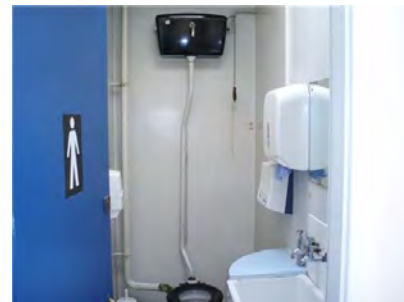
Ref	Status	Sample No.	Location	Extent	Type	Material score	Material risk	Priority	Overall risk	Resurvey date
70	Presumed	01030-01-05-SP01	01 00 School Building 005 Staff WC Ground : WC	SMALL AMOUNT	Crocidolite	6	B	3	Low	12/06/2026
<p><b>Description</b></p> <p><b>Notes</b> Office WC Male &amp; Female not sampled. Strongly presumed asbestos</p> <p><b>Accessed during survey</b> Yes</p> <p><b>Recommendations</b></p> <ul style="list-style-type: none"> <li>• Monitor &amp; Manage</li> </ul>

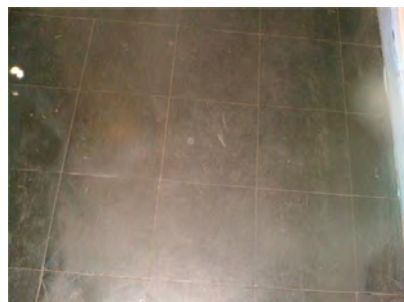
Ref	Status	Sample No.	Location	Extent	Type	Material score	Material risk	Priority	Overall risk	Resurvey date
67	Tested Positive	01030-01-08-03	01 00 School Building 008 StorageGround : STAFF ROOM	6M2	Chrysotile	4	B	7	Low	12/06/2026
<p><b>Description</b></p> <p><b>Accessed during survey</b> Yes</p> <p><b>Recommendations</b></p> <ul style="list-style-type: none"> <li>• Monitor &amp; Manage</li> </ul>

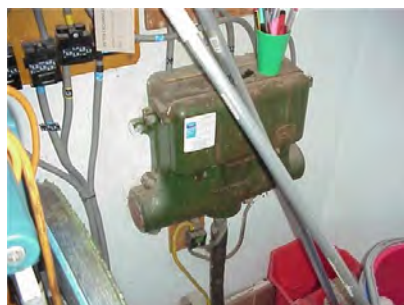
Ref	Status	Sample No.	Location	Extent	Type	Material score	Material risk	Priority	Overall risk	Resurvey date
65	Presumed	01030-01-10-P14	01 00 School Building 010 Ctkr/Site Mgr Office Ground :	< 1 LINER METRE	Chrysotile	6	B	4	Low	12/06/2026
<p><b>Description</b></p> <p><b>Notes</b> Rope Flash guards within fuse box presumed to contain asbestos. Limited access gained above the ceiling.</p> <p><b>Accessed during survey</b> Yes</p> <p><b>Recommendations</b></p> <ul style="list-style-type: none"> <li>• Monitor &amp; Manage</li> </ul>

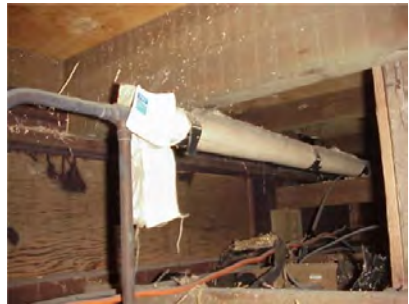
Ref	Status	Sample No.	Location	Extent	Type	Material score	Material risk	Priority	Overall risk	Resurvey date
63	Tested Positive	01030-01-11-01	01 00 School Building 011 ClassroomGround : CEILING VOID	4 LINEAR METRES	Chrysotile	5	B	5	Low	12/06/2026
<p><b>Description</b></p> <p><b>Notes</b> Paper beneath versal insulation to pipework within the ceiling void. Limited access gained above the ceiling. Restrict access above the ceiling. Label paper.</p> <p><b>Accessed during survey</b> No</p> <p><b>Recommendations</b></p> <ul style="list-style-type: none"> <li>• Restrict Access</li> </ul>

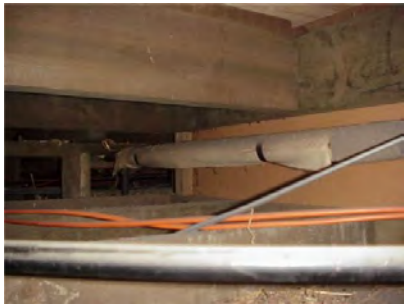
Ref	Status	Sample No.	Location	Extent	Type	Material score	Material risk	Priority	Overall risk	Resurvey date
61	Presumed	01030-01-14-P04	01 00 School Building 014 StorageGround : CEILING VOID		Chrysotile	5	B	6	Low	12/06/2026
<b>Description</b>  <b>Notes</b> Paper below versal insulation to pipework within the ceiling void, presumed to contain asbestos as previous sample no. 01030-01-11-01. Limited access gained above the ceiling.  <b>Accessed during survey</b> No  <b>Recommendations</b> <ul style="list-style-type: none"> <li>Restrict Access</li> </ul>

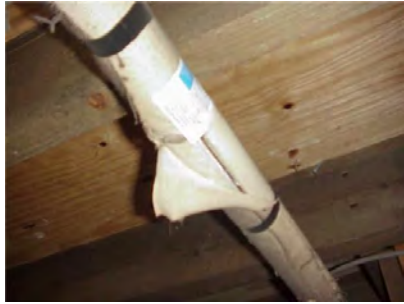
Ref	Status	Sample No.	Location	Extent	Type	Material score	Material risk	Priority	Overall risk	Resurvey date
60	Presumed	01030-01-15-SP02	01 00 School Building 015 ClassroomGround : CEILING VOID	6 LINEAR METRES	Chrysotile	4	B	5	Low	12/06/2026
<b>Description</b>  <b>Notes</b> Paper below versal insulation to pipework within ceiling void presumed to contain asbestos as previous sample no. 01030-01-11-01.  <b>Accessed during survey</b> No  <b>Recommendations</b> <ul style="list-style-type: none"> <li>Restrict Access</li> </ul>

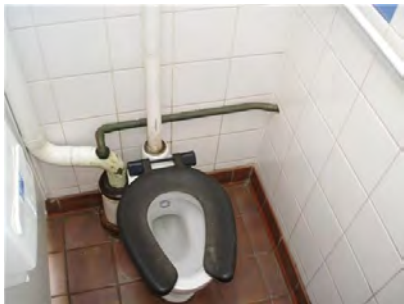
Ref	Status	Sample No.	Location	Extent	Type	Material score	Material risk	Priority	Overall risk	Resurvey date
55	Presumed	01030-01-18-SP02	01 00 School Building 018 Pupil WC Ground : CISTERN	SMALL AMOUNT	Crocidolite	6	B	3	Low	12/06/2026
<b>Description</b>  <b>Notes</b> Childrens WC not sampled. Strongly presumed asbestos  <b>Accessed during survey</b> Yes  <b>Recommendations</b> <ul style="list-style-type: none"> <li>Monitor &amp; Manage</li> </ul>

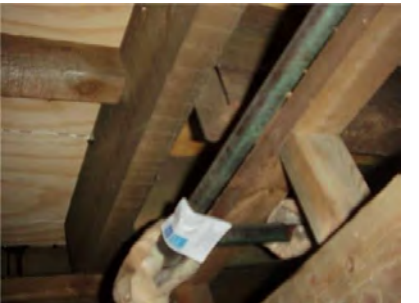
Ref	Status	Sample No.	Location	Extent	Type	Material score	Material risk	Priority	Overall risk	Resurvey date
50	Tested Positive	01030-01-22-08	01 00 School Building 022 StorageGround : CEILING VOID	2 LINEAR METRES	Chrysotile	5	B	7	Low	12/06/2026
<p><b>Description</b></p> <p><b>Notes</b> Paper below the versal insulation to pipework within the ceiling void. Limited access gained above the ceiling. Label paper. Restrict access above the ceiling.</p> <p><b>Accessed during survey</b> No</p> <p><b>Recommendations</b></p> <ul style="list-style-type: none"> <li>• Restrict Access</li> </ul>

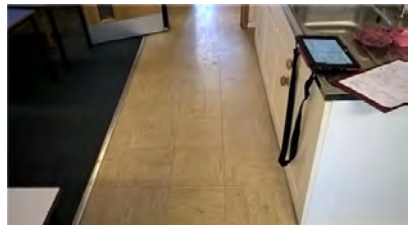
Ref	Status	Sample No.	Location	Extent	Type	Material score	Material risk	Priority	Overall risk	Resurvey date
49	Tested Positive	01030-01-23-01	01 00 School Building 023 ClassroomGround : FLOOR	25M2	Chrysotile	3	A	8	Low	12/06/2026
<p><b>Description</b></p> <p><b>Notes</b> Partly under blue carpet. Same tiles observed in rooms 17 and 20 so recommend additional testing of the vinyl tiles in these rooms prior to any works.</p> <p><b>Accessed during survey</b> Yes</p> <p><b>Recommendations</b></p> <ul style="list-style-type: none"> <li>• Monitor &amp; Manage</li> </ul>

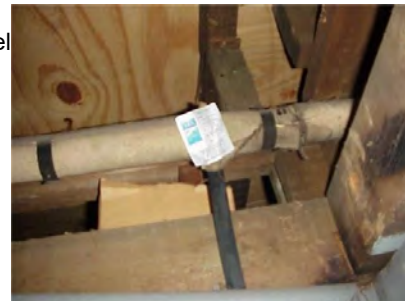
Ref	Status	Sample No.	Location	Extent	Type	Material score	Material risk	Priority	Overall risk	Resurvey date
47	Presumed	01030-01-23-P09	01 00 School Building 023 ClassroomGround :	4 LINEAR METRES	Chrysotile	5	B	7	Low	12/06/2026
<p><b>Description</b></p> <p><b>Notes</b> Paper lining below versal insulation to piepwork within the ceiling void presumed to contain asbestos as previous sample no. 01030-01-22-08. Limited access gained above the ceiling. Label paper. Restrict access above the ceiling.</p> <p><b>Accessed during survey</b> No</p> <p><b>Recommendations</b></p> <ul style="list-style-type: none"> <li>Restrict Access</li> </ul>

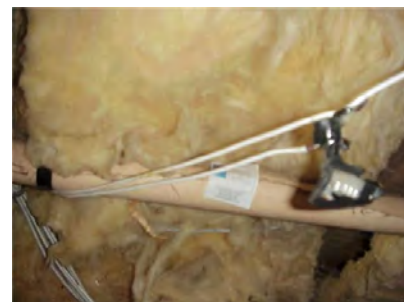
Ref	Status	Sample No.	Location	Extent	Type	Material score	Material risk	Priority	Overall risk	Resurvey date
42	Presumed	01030-01-37-P10	01 00 School Building 037 OtherGround : CEILING VOID	3 LINEAR METRES	Chrysotile	5	B	7	Low	12/06/2026
<p><b>Description</b></p> <p><b>Notes</b> Paper lining below the versal insulation to pipework presumed to contain asbestos as previous sample no. 01030-01-22-08.</p> <p><b>Accessed during survey</b> No</p> <p><b>Recommendations</b></p> <ul style="list-style-type: none"> <li>Restrict Access</li> </ul>

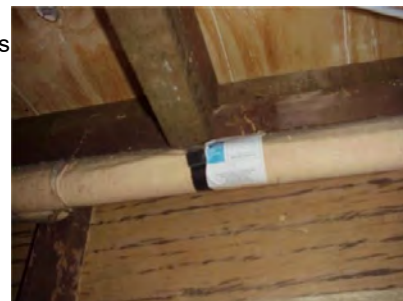
Ref	Status	Sample No.	Location	Extent	Type	Material score	Material risk	Priority	Overall risk	Resurvey date
41	Presumed	01030-01-37-P11	01 00 School Building 037 OtherGround : ADJACENT 37, 9, 23 & 24.	3 LINEAR METRES	Chrysotile	5	B	7	Low	12/06/2026

Paper below versal insulation to pipework within the ceiling void presumed to contain asbestos as previous sample no. 01030-01-22-08.

- Restrict Access

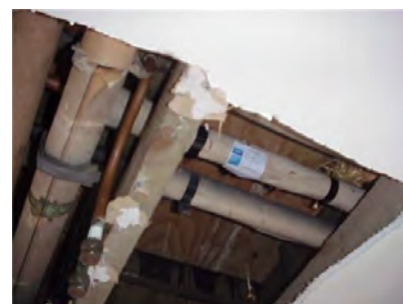
Ref	Status	Sample No.	Location	Extent	Type	Material score	Material risk	Priority	Overall risk	Resurvey date
40	Tested Positive	01030-50-01-15	50 00 Catering Services 001 KitchenGround : CEILING VOID	30 LINEAR METRES	Chrysotile	5	B	5	Low	12/06/2026

Paper lining below versal insulation to pipework within the ceiling void.

- Restrict Access

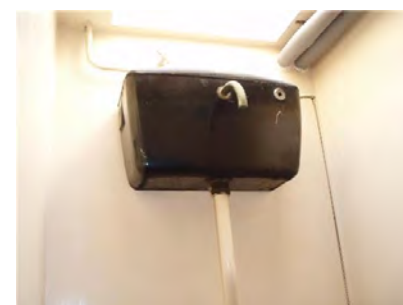
Ref	Status	Sample No.	Location	Extent	Type	Material score	Material risk	Priority	Overall risk	Resurvey date
37	Presumed	01030-50-04-SP05	50 00 Catering Services 004 Staff WCGround : CISTERN	SMALL AMOUNT	Crocidolite	6	B	3	Low	12/06/2026

Kitchen WC not sampled. Strongly presumed asbestos

- Monitor & Manage

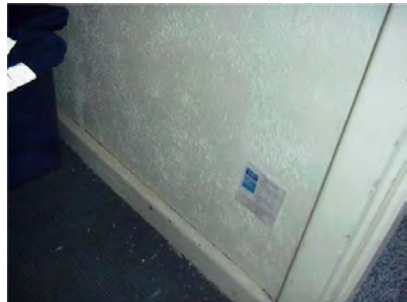
Ref	Status	Sample No.	Location
68	Tested Negative	01030-01-07-13	01 00 School Building 007 Staff RoomGround :
<b>Description</b>  <b>Notes</b> Textured coating to plasterboard walls. Limited access was gained above the ceiling.  <b>Accessed during survey</b> Yes

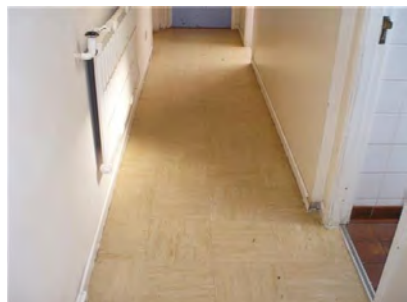
Ref	Status	Sample No.	Location
58	Tested Negative	01030-01-17-02	01 00 School Building 017 CirculationGround : FLOOR
<b>Description</b>  <b>Notes</b> These are the same tiles as sample 01030-01-23-01 which is positive for asbestos so recommend additional tests on the tiles in room 17 prior to any works.  <b>Accessed during survey</b> Yes

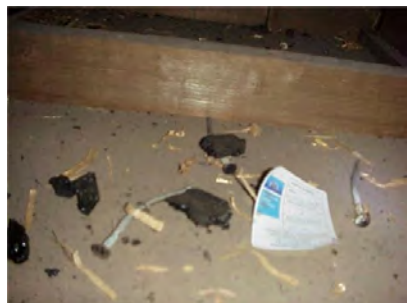
Ref	Status	Sample No.	Location
52	Tested Negative	01030-01-20-07	01 00 School Building 020 ClassroomGround : CEILING VOID
<b>Description</b>  <b>Notes</b> Bitumen debris to the tops of the ceiling tiles. Limited access gained above the ceiling. Restrict access above the ceiling tiles.  <b>Accessed during survey</b> Yes

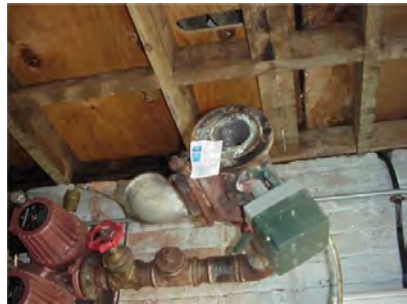
Ref	Sample No.	Location	Extent	Type	Material score	Material risk	Priority	Overall risk
43	01030-01-25-06	01 00 School Building 025 Boiler RoomGround :	< 1 SQUARE METRE	Chrysotile	5	Removed	5	Removed
<b>Description</b>  <b>Notes</b> Gasket to pipe flange.  <b>Accessed during survey</b> Yes

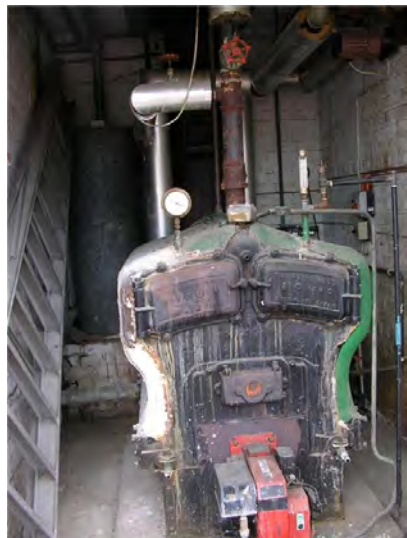
Ref	Sample No.	Location	Extent	Type	Material score	Material risk	Priority	Overall risk
45	01030-01-25-SP04	01 00 School Building 025 Boiler RoomGround : BOILER	SMALL AMOUNT	Crocidolite		Removed		Removed
<b>Description</b>  <b>Notes</b> Boiler working at time of survey. Unable to sample due to clutter.  <b>Accessed during survey</b> Yes

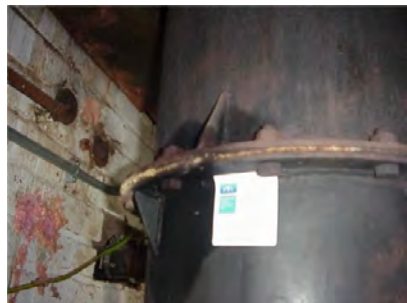
Ref	Sample No.	Location	Extent	Type	Material score	Material risk	Priority	Overall risk
46	01030-01-25-SP05	01 00 School Building 025 Boiler RoomGround :	2 LINEAR METRES	Chrysotile	7	Removed	7	Removed
<b>Description</b>  <b>Notes</b> Rope seal to flange on steel flue pipe.  <b>Accessed during survey</b> Yes
